# Manhole Inspection Summary

Manhole # S1900\_022MH

Insp Date: **7/6/07 10:08 AM**

**Location** Address: **2324 MONROE-REISTERSTOWN** Cross Street: **BRYANT AVE**

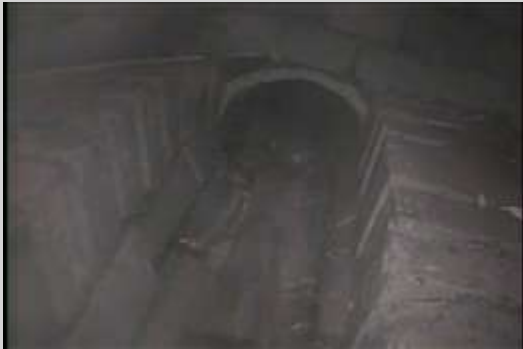
12 O'Clock Outflow

8 in. Circular Gravity Sewer  
Pipe Out @ 12 O'Clock

Pipe Height: **7.2** (in.) Rod and Bar (Angled)  
Pipe Material: **Clay** ☐ Pipe Lined  
Invert Depth: **7.27** (ft.) Flow Characteristics: **Slow**  
Deposits: ☐ None ☐ Mud ☐ Sludge ☒ **Debris** ☐ Grease  
Silt Depth: **1** (in.) Deposits Extent: **Light**  
Infiltration: **None** Pipe Seal Cond: **Sound**

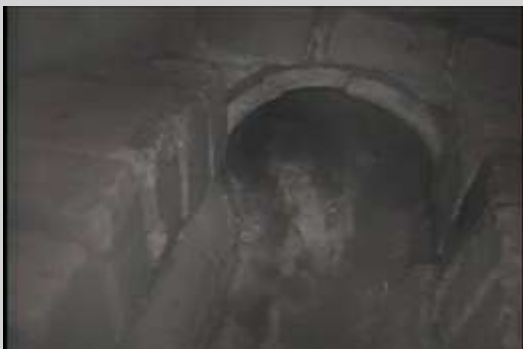
6 O'Clock Inflow

8 in. Circular Gravity Sewer  
Pipe In @ 6 O'Clock

Pipe Height: **7.2** (in.) Rod and Bar (Angled)  
Pipe Material: **Clay** ☐ Pipe Lined  
Invert Depth: **7.03** (ft.) Flow Characteristics: **Slow**  
Deposits: ☐ None ☐ Mud ☐ Sludge ☒ **Debris** ☐ Grease  
Silt Depth: **3** (in.) Deposits Extent: **Medium**  
Infiltration: **None** Pipe Seal Cond: **Cracked**
